MID-AMERICA PIPELINE SYSTEM
LIQUEFIED PETROLEUM GAS PIPELINE
RUPTURE AND FIRE
DONNELLSON, IOWA
AUGUST 4, 1978

1. Report No. NTSB-PAR-79-1		2. Government Accession No.		3. Recipient's Catalog No.	
4. Title and Subtitle Pipeline Accident Report -- Mid-America Pipeline System Liquefied Petroleum Gas Pipeline Rupture and Fire, Donnellson, Iowa, August 4, 1978				5. Report Date May 3, 1979

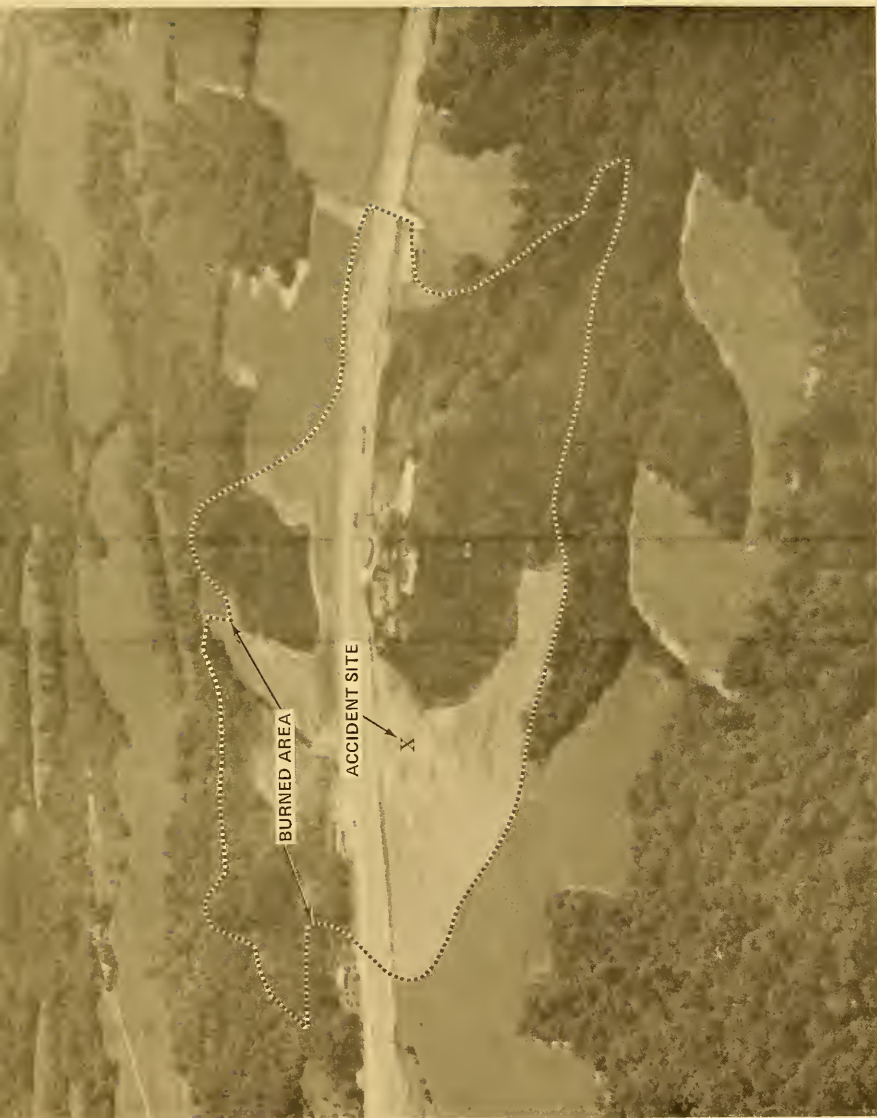
firefighters found the farmhouse had already been leveled by the intense fire and there was a towering column of fire about 400 feet high located in a cornfield north of the farmhouse. Between 12:20 and 12:25 a.m., the Donnellson, Iowa Volunteer Fire Department arrived at the scene and both departments began extinguishing numerous brush fires. (See figure 1.)

Figure 1. View of the burned area.

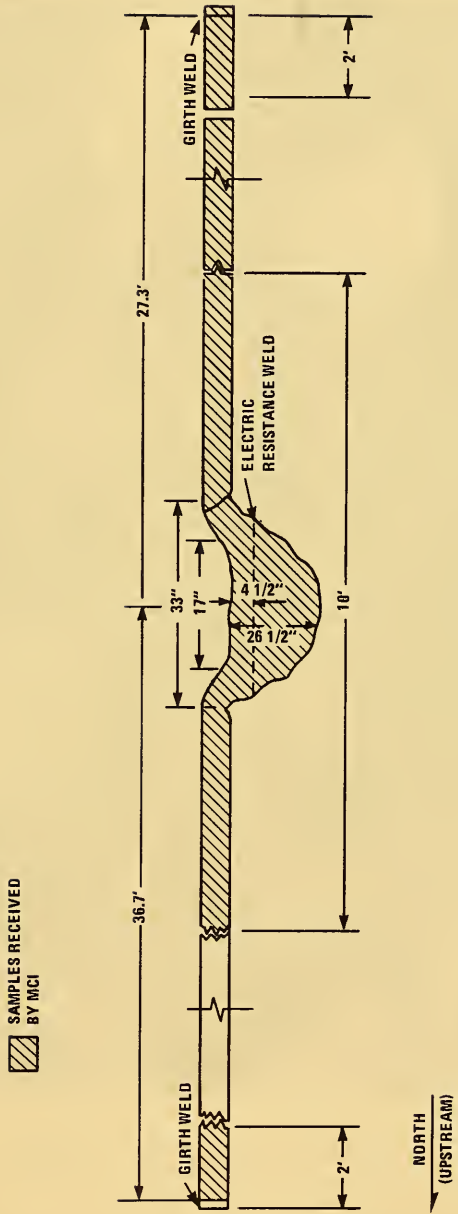
A segment of 8-inch pipe approximately 64 feet long containing the 3-foot ruptured section was removed from the system. (See figure 3.) Approximately 3,750 barrels (157,500 gallons) of liquid propane had vaporized and burned.

Figure 3. An 8-inch segment of pipe containing the 3-foot ruptured section.

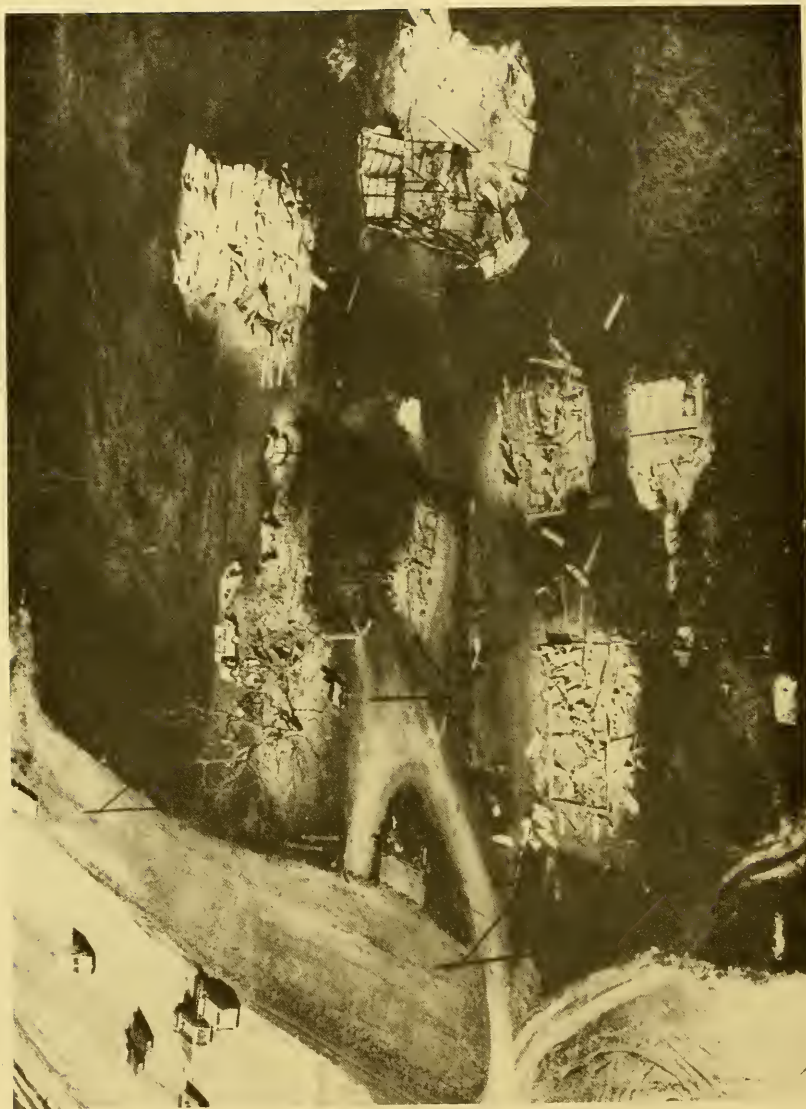
One farmhouse, six outbuildings, and an automobile were destroyed (see figure 4), and two houses and an automobile were damaged by the fire. Electric power lines and telephone lines were burned down and approximately 75 acres of woods and cornfields were burned.

Figure 4. An aerial view of the farmhouses and other outbuildings destroyed.

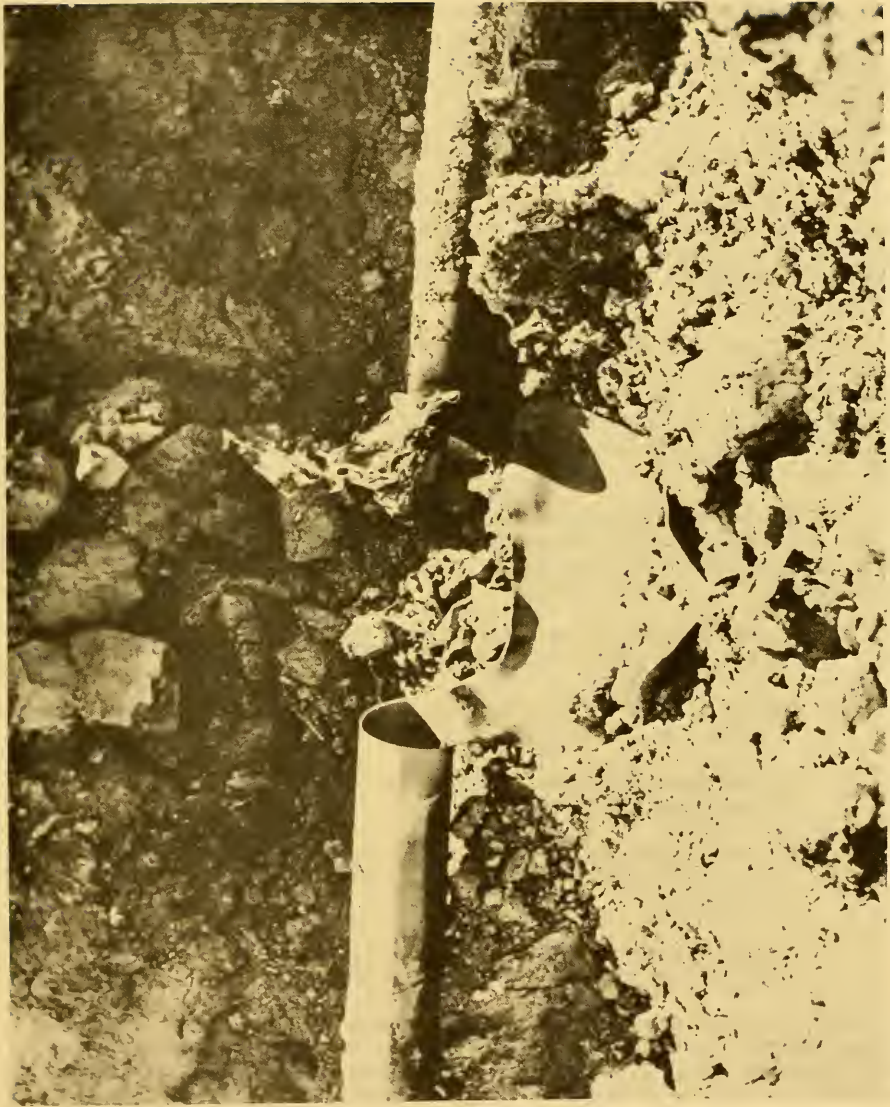
On August 4, 1978, a 64-foot section of pipe was removed at the rupture site. Three samples were cut from the section for metallurgical analysis and examination: a 10-foot section which contained the failure, and two 2-foot pieces from each end of the failed length of pipe. (See figure 6.) The Safety Board retained Metallurgical Consultants, Inc., of Houston, Texas, to conduct testing and metallurgical analysis of the failed pipe.

Figure 6. Drawing showing details of ruptured pipe and location of samples.

The metallurgical examination concluded that the failure of the pipe was caused by external mechanical damage in the form of a dent and a gouge. The damage was located at the 4 o'clock position in the pipe. The damaged section was relatively small and would have been difficult to detect with the naked eye. Because of fire damage to the pipe, it was impossible to determine whether the dent and gouge occurred before or after coating operations. (See appendix A.)

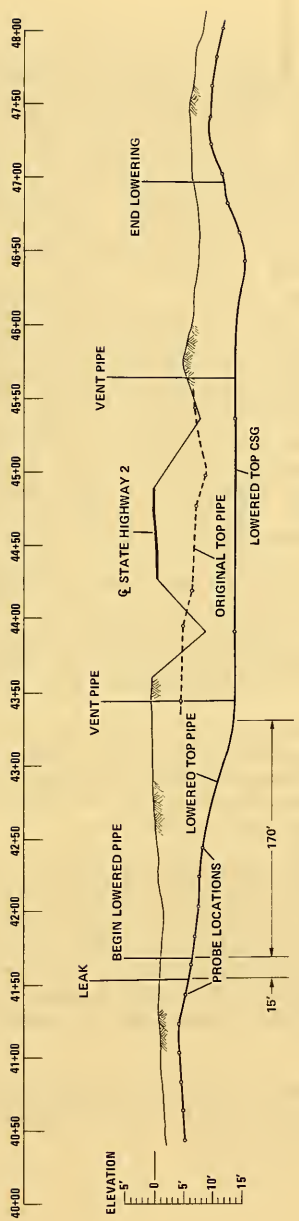
Three months before the accident, MAPCO completed lowering a section of the Farmington lateral under Highway 2 adjacent to the accident site. (See figure 7.) After the accident, it was determined that MAPCO had started lowering the pipeline 15 feet from where the rupture occurred and the pipe elevation had changed 10 feet along 170 feet of pipe north from that point.

The report further concluded that these combined stresses, when applied at the location of the dent and gouge, caused a stress concentration that increased the total stress by 2 to 3 times. This total stress far exceeded the tensile strength of the pipe steel and caused the pipeline to rupture at the weakened point. The calculations represent an order of magnitude of forces imposed upon the pipeline at the time of the accident.

Figure 7. Drawing showing elevation of pipeline.

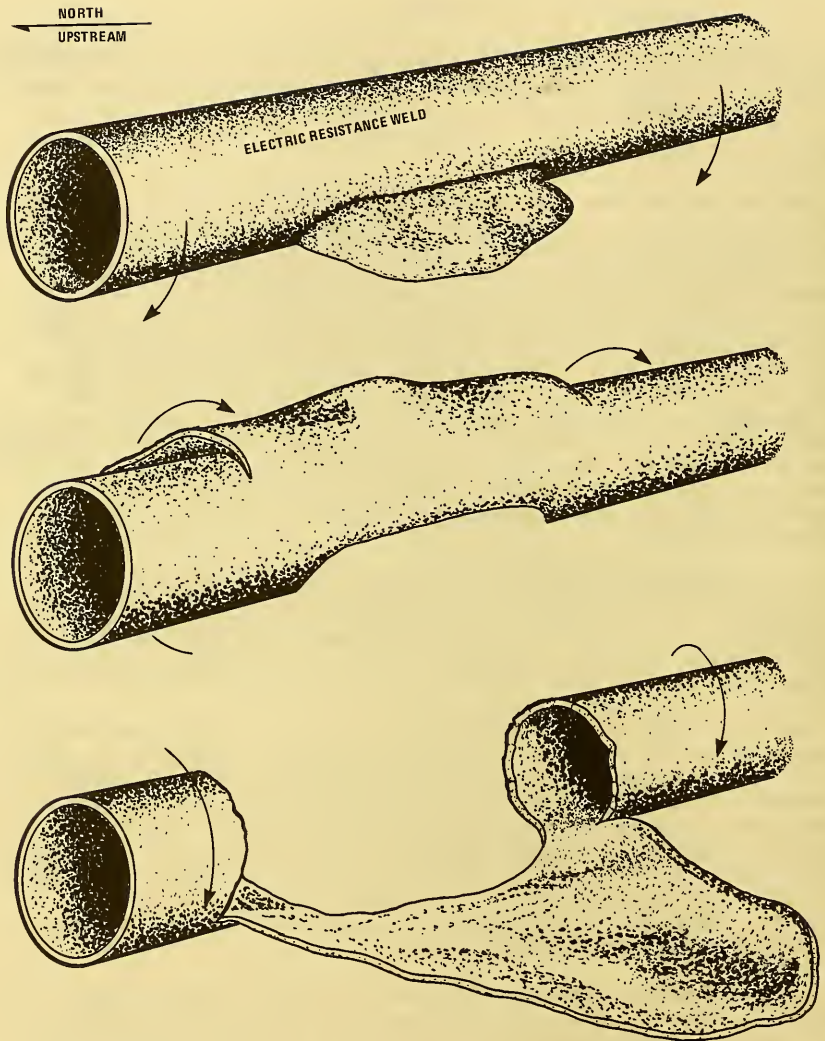
The rupture was approximately 33 inches long and originated on the west side of the line. It propagated longitudinally about 17 inches and then spiralled over 360 degrees at each end and stopped. The failed section created by the force of the failure as the pipe wall was blown outward below the fracture traveled under and around the pipe. (See figure 8.) Close examination of the outside surface showed gouge marks along and on either side of the fracture. The most severe gouge was approximately 7 1/2 inches long and 1/4 inch wide and located along the bottom side of the fracture. (See figure 9.) The fracture surfaces near the center of this gouge were very flat and brittle--appearing over a length of about 2 1/2 inches. The fracture changed from flat to approximately 45 degrees with the typical appearance of shear. The fracture surface also reveals an irregular fracture profile with fine cracks on each side of the fracture. The depth of the gouge was approximately 0.005 to 0.007 inch.

Figure 8. Drawings showing how "flap" was blown out and around the pipe ending up on the west side of the line.

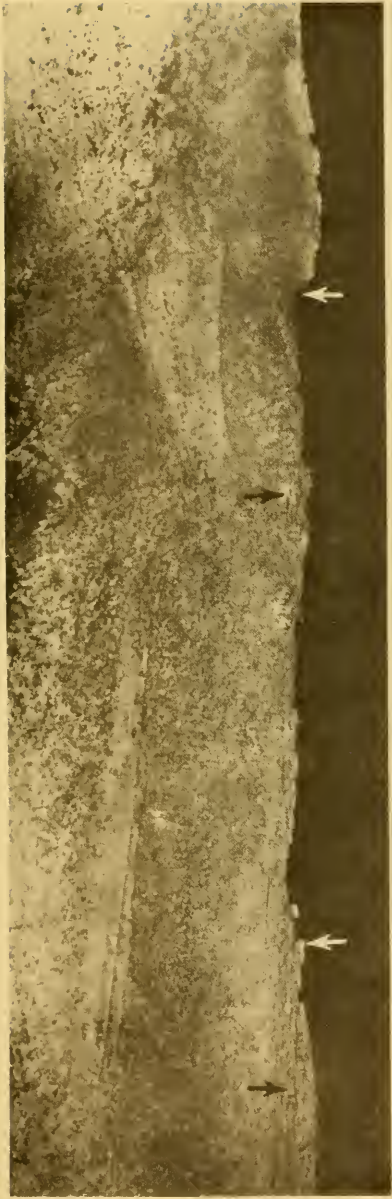
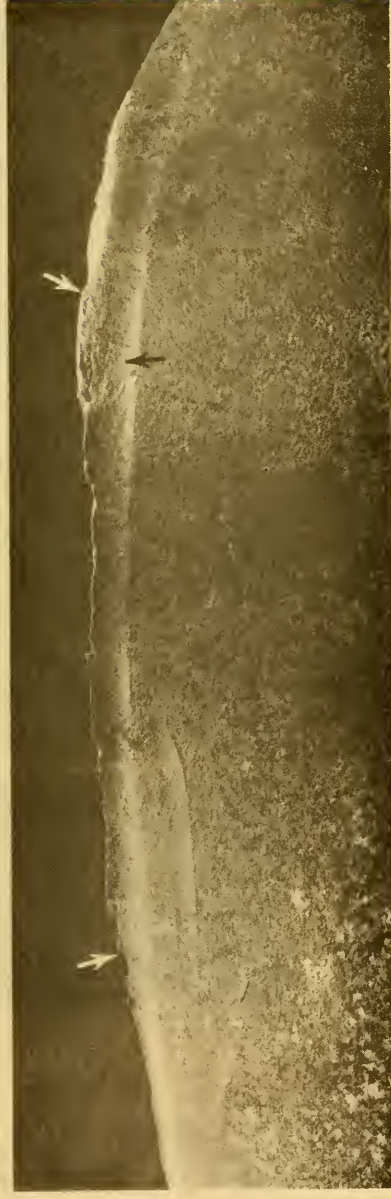
Sections for metallographic examination were cut across the fracture and gouge at four locations within the white arrows. Matching specimens were cut from above and below the fracture, mounted together, polished, and etched. The manner in which the matching fractures fit together indicate that the pipe had been dented as well as gouged. (See figure 10.) On three of the sections, small secondary cracks were found. The largest crack as shown in section B was approximately 0.015 inch deep. It was very straight for a depth of about 0.008 inch, then veered off at an angle. The offset in the fracture at the outside surface was similar in shape to the small crack. (See figure 9.)

Figure 9. Outside surface showing gouge along the fracture. The white arrows indicate the location of flat fracture; the black arrows indicate secondary cracks.

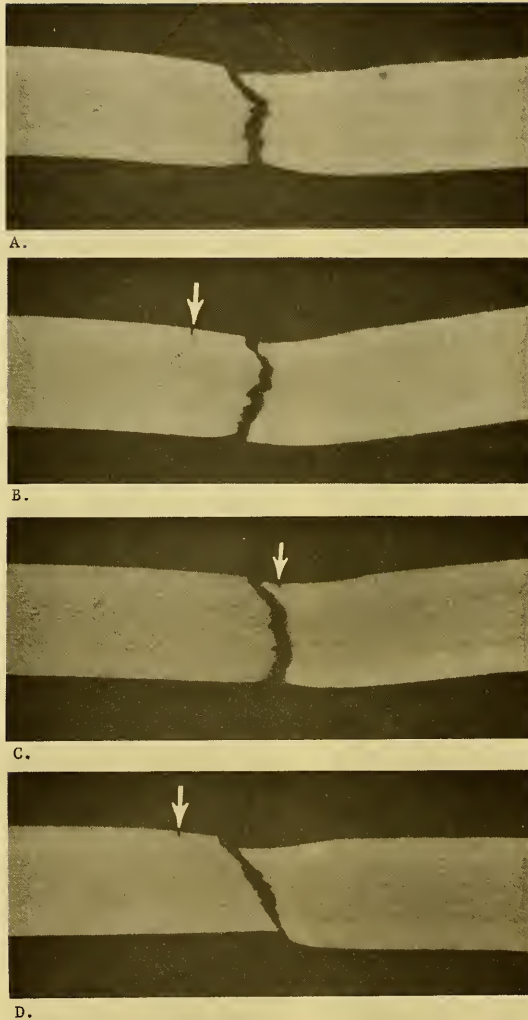
Figure 10. Sections across the rupture origin at four locations. A and B are from the right one-third of the origin; C is near the center, and D is near the left end where the fracture was changing from flat to 45-degree shear. The top of the fracture is at left. The arrows indicate secondary cracks.
